Regarding: Reserve Study Final Version

Level 2, Premium Reserve Analysis

# Roaring River Lodges Condo Assoc. 23300 Two Rivers Road Basalt, CO. 81621

## FINAL VERSION

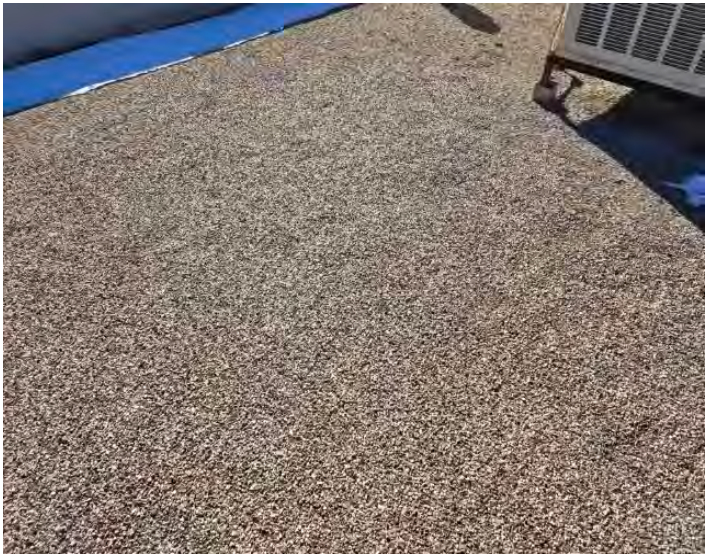
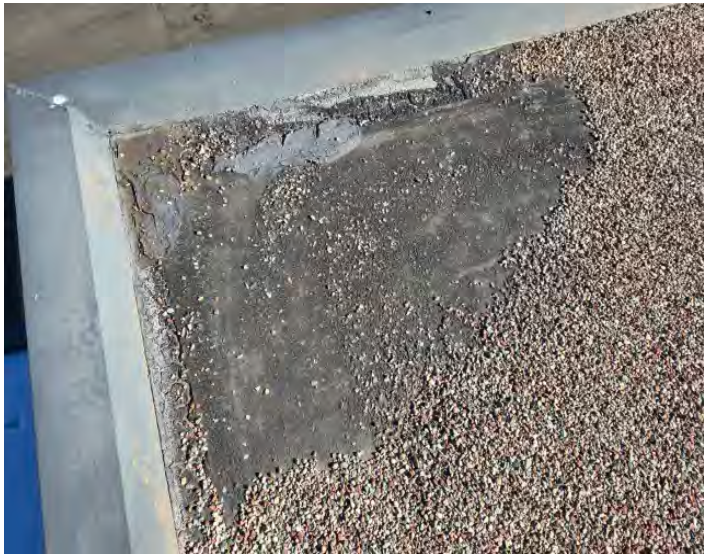
Comp #: 102      Flat Roof - Replace

- Based on the reported age and condition of the roof, it is recommended the association prepares for replacement and we recommend replacing with a EPDM or TPO material so that it can be coated in the future, rather than a costly replacement expense.
- Once replaced and the type of roof is determined, Reserve funding can be adjusted in future Reserve Studies for a coating to be applied, rather than replacement.
- Coating is a less expensive alternative to replacing the roof and has as similar life expectancy.
- The replacement cycle is set at 48 years to be conservative as it is possible that only so many coatings will be allowed in the future due to the weight of the material building up over a period of time and replacement will be likely at some point in the future

*Best Cost:*                    **\$260,000**  
\$2,000/square; Estimate to replace

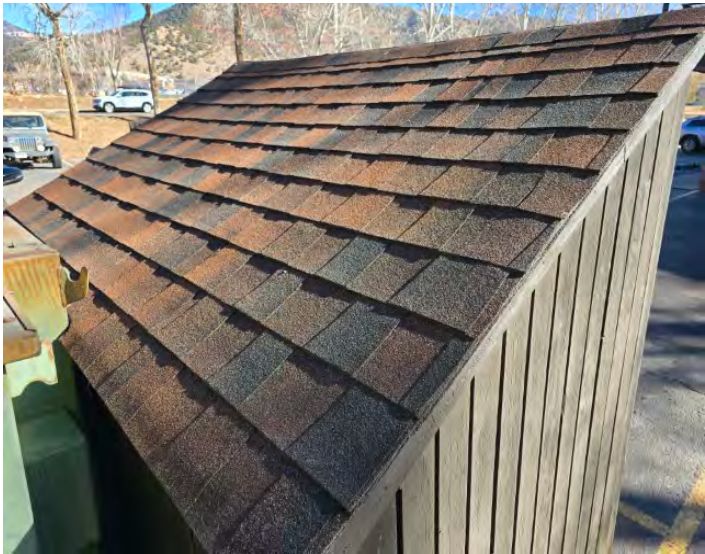
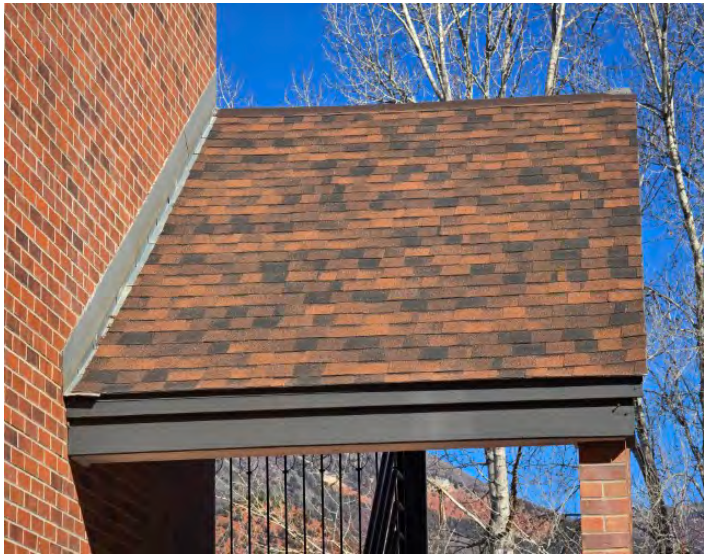
Comp Shingle Roof - Replace (Commercial)

- The roofs were previously wood shake roofs that covered the stairwells, as well as the trash enclosures. It is unknown when these roofs were replaced, but it appears these were replaced within the past 4 - 7 years. This roof appears to be a "40-year" rated shingle. Due to the harsh winters, extensive freeze/thaw cycle, and high UV levels over the useful life of the roof, we typically see associations replacing roofs sooner than the manufacturer's suggested useful life.
- Remaining life is based on age of roof and observed conditions.
- Cost to replace these roofs is higher on a per unit of measure basis due to the small area and the expense it would take to mobilize a crew to perform the work.

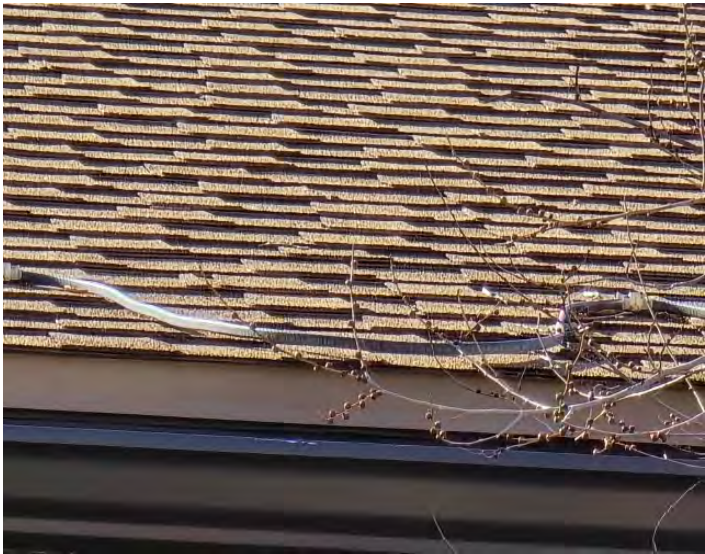
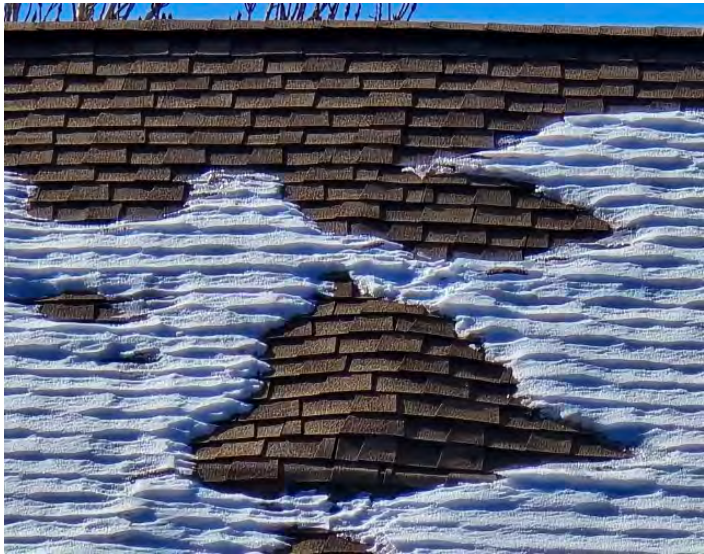
Comp Shingle Roof - Replace (Residential)

- Roof is in poor condition with sagging noted between roof joists noted. This could be from rotted sheathing or normal wear and tear and settling from snowloads over the years. Final consensus will not be determined until the contractor tears off the roof layer to inspect and evaluate the base materials. It is possible the roof will need to be completely reconstructed once further inspections take place.
- Association has received estimates to replace the roof, but estimated cost of This roof appears to be a "40-year" rated shingle. Due to the harsh winters, extensive freeze/thaw cycle, and high UV levels over the useful life of the roof, we typically see associations replacing roofs sooner than the manufacturer's suggested useful life.
- Remaining life is based on age of roof and observed conditions.

*Best Cost:* **\$76,500**  
\$900/square; Estimate to remove and replace

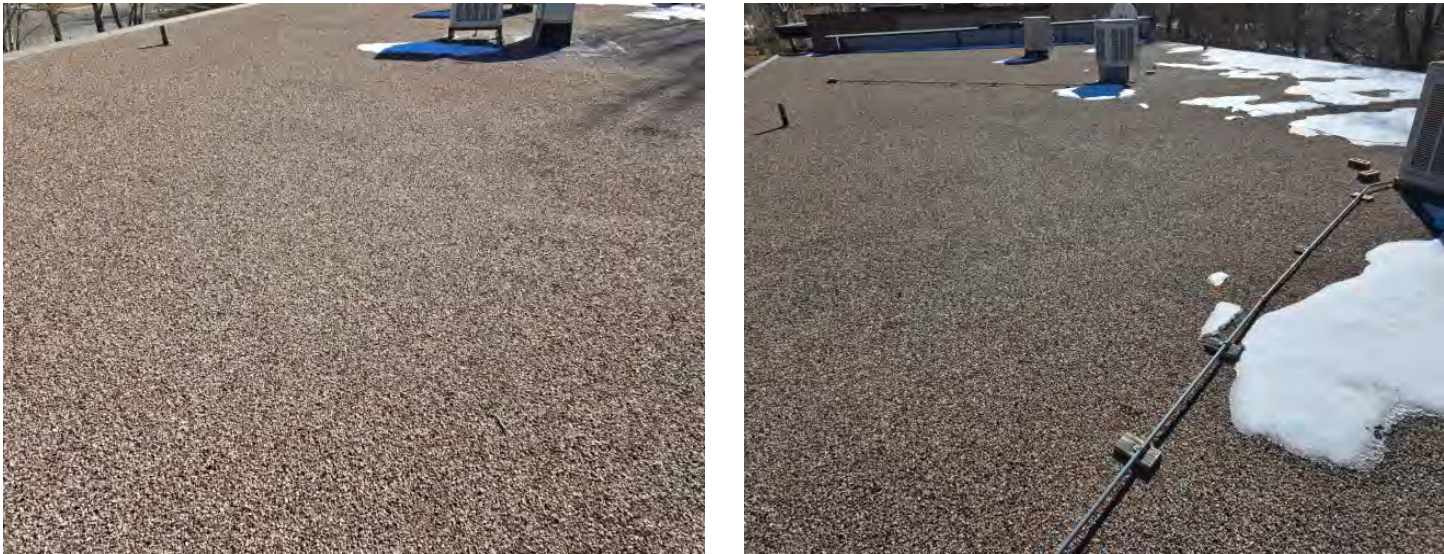
Flat Roof - Coating

- This type of roof has a 17 - 20 year life expectancy as long as proper maintenance and limited foot traffic is achieved over the duration of the life of the roof
- Depending on the integrity of the roof membrane, it is possible a coating can be applied
- Typically, the membrane starts to break down about 15 years after installation. Association should start getting a roof inspection done every year following the 10 year mark to determine when a coating can be applied rather than waiting for replacement, which would be more costly.
- We have established a life expectancy of 16 years for applying a coating as most warranties for coating products currently range from 12 - 18 years, depending on the quality of coating the association selects
- The remaining life is equal to the Useful Life since it is not necessary to coat the roof right after installation.

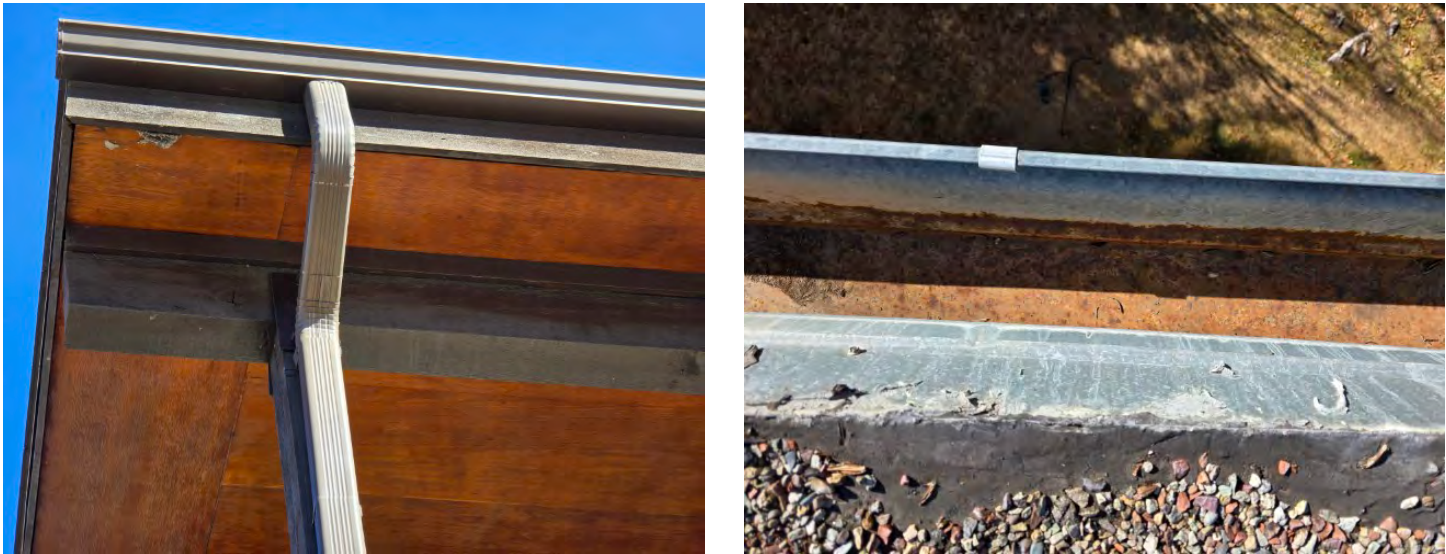
Gutters/Downspouts - Replace

- It appears that the gutters at 23400 are newer and 23300 is old and rusted, with some holes present.
- It was reported the gutters and downspouts for the residential roof will be replaced at the same time the roof is replaced.
- Damaged extensions can be replaced as needed with general operating funds.
- The life expectancy for gutters and downspouts ranges between 20 - 30 years, depending on maintenance.
- Keep gutters and downspouts free from debris which can cause corrosion of metal materials or blockage which can cause the downspouts to freeze and expand during winter months.
- Expect to replace at same time as roof replacement for best drainage and best replacement cost.
- Due to varying ages of conditions, we have established Reserve funding for partial replacement (approximately 300 LF) every 10 years

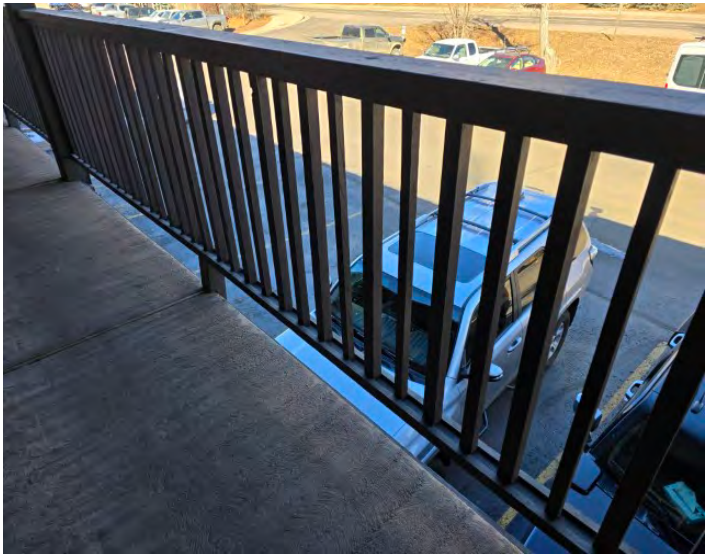
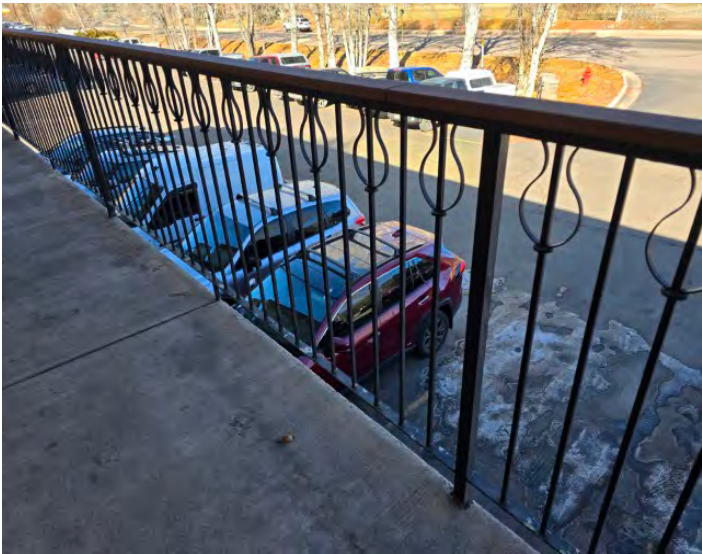
Metal/Wood Railing - Repaint

- It was reported that the railings were repainted at the same time as the railing cap replacement project within the past couple years. Observations revealed good conditions with no concerns noted.
- In this climate, we recommend repainting this component every 3 - 4 years to maintain appearance and protect metal surfaces.
- Remaining life based on age of painted surfaces and current condition.

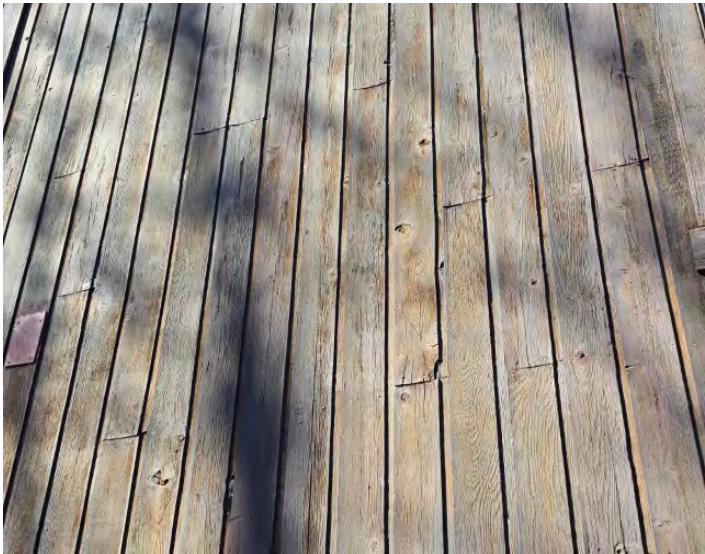
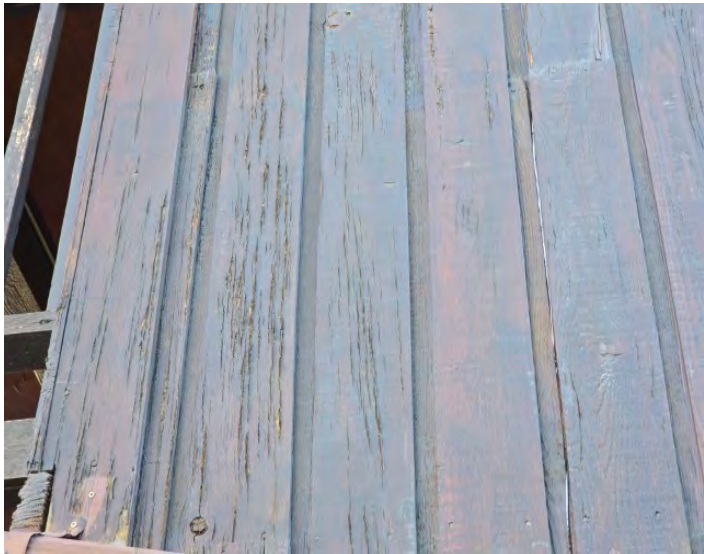
Cedar/Wood Siding - Major Repairs

- Observations:
- Bldg. 23284 will probably need new siding soon as there are a lot of splits in the wood and possible water intrusion areas with the split wood
  - It is unlikely that the association will replace all of the siding at the same time.
  - Therefore, we recommend replacing large sections, often referred to "fields", of the siding as part of prep work before painting.
  - When replacement of a large section is required, we recommend replacing an entire field at the same time for best appearance
  - Materials we recommend using currently is manufactured from LP and is called "Smart Siding"

Best Cost: **\$54,250**  
Estimate for major repairs

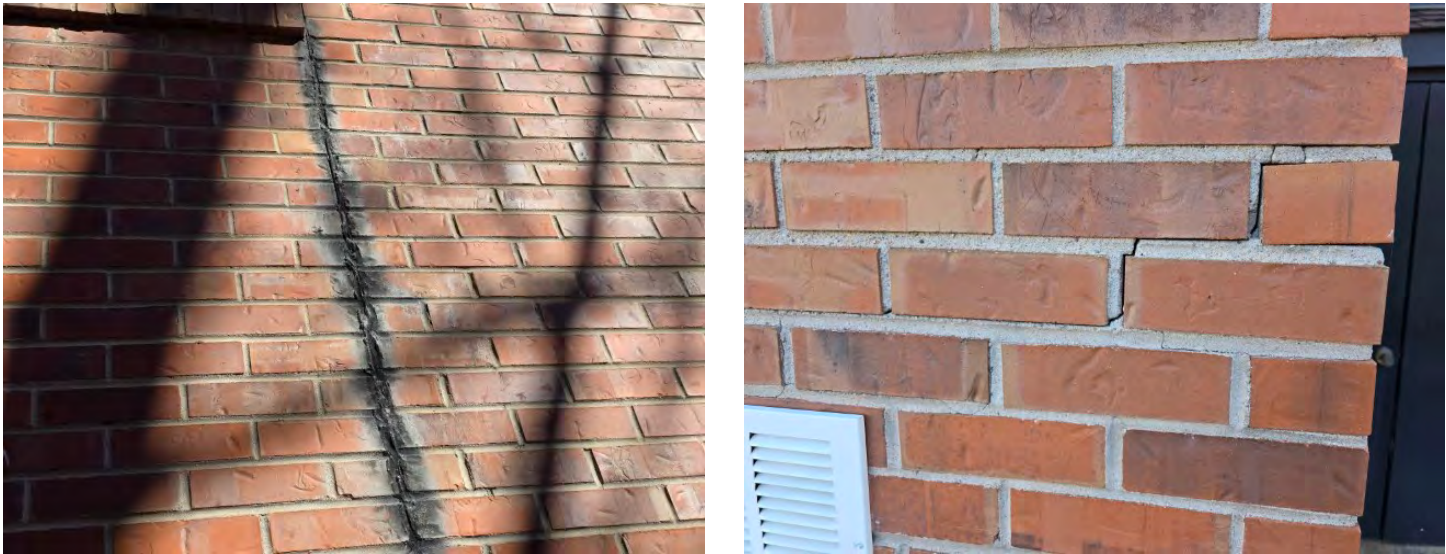
Brick - Major Repairs/TuckPoint

- Client requested installing brick over stucco due to damage sustained to the stucco surfaces from constant exposure to irrigation spray from sprinkler system. We do not recommend installing brick over an existing surface due to masking potential damage to the base materials. Stucco should be removed prior to installing brick over an existing surface. Due to varying levels of cost depending on the results of the inspection, this capital improvement upgrade should be handled with funds separate from the Reserve account.

- Typically, bricks have an extended life expectancy and complete replacement is unlikely.
- We noted a few areas that had cracks in the mortar. Repairs to these materials is called tuckpointing.

- There are times where minor repairs may become necessary, but this is unpredictable when and how much would occur.
- Based on the age of the buildings and the observed conditions, we recommend establishing funds for periodic inspections and repairs to prevent any water intrusion points that could cause damage

- Coordinate repairs with painting cycles to address all exterior building clad materials at the same time.

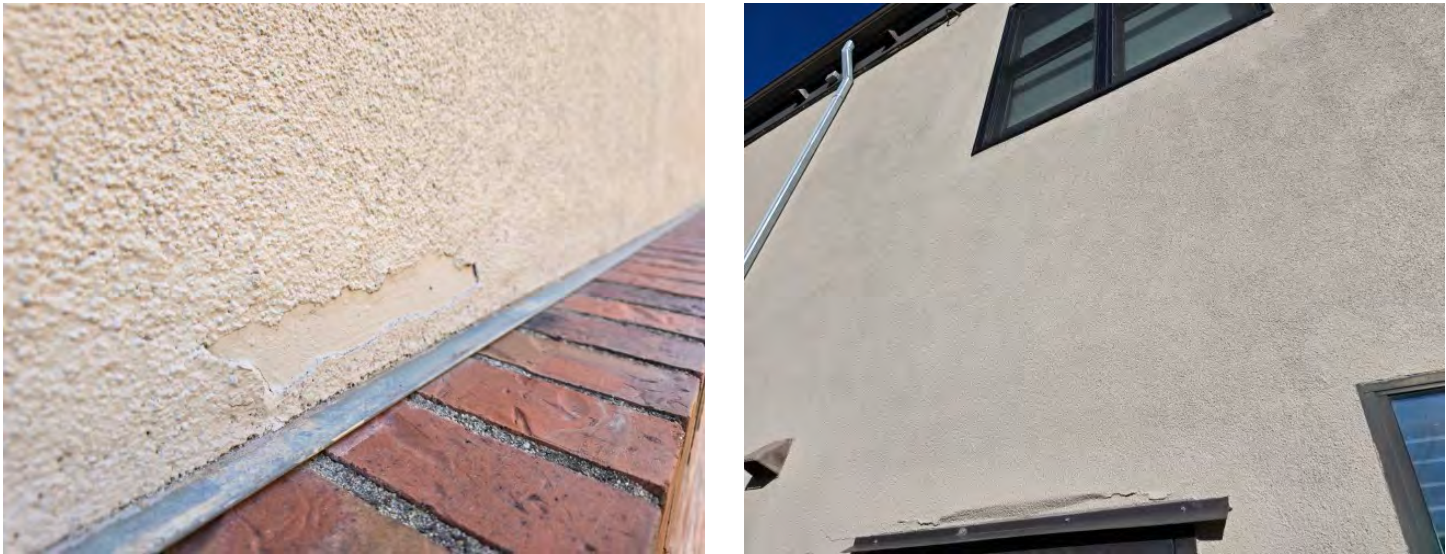
Stucco - Inspect/Major Repairs

- Client requested installing brick over stucco due to damage sustained to the stucco surfaces from constant exposure to irrigation spray from sprinkler system. We do not recommend installing brick over an existing surface due to masking potential damage to the base materials. Stucco should be removed prior to installing brick over an existing surface. Due to varying levels of cost depending on the results of the inspection, this capital improvement upgrade should be handled with funds separate from the Reserve account.

- While stucco surfaces typically have a long-life expectancy, it is recommended by industry professionals that stucco is inspected, and any voids are repaired every 5 - 10 years to prevent water intrusion into substrate.

- Over a period of time, minor cracks and voids will develop which will require repairing.
- Typically these inspections occur at the time of the painting cycle in case the repairs need to be painted to match existing surfaces.

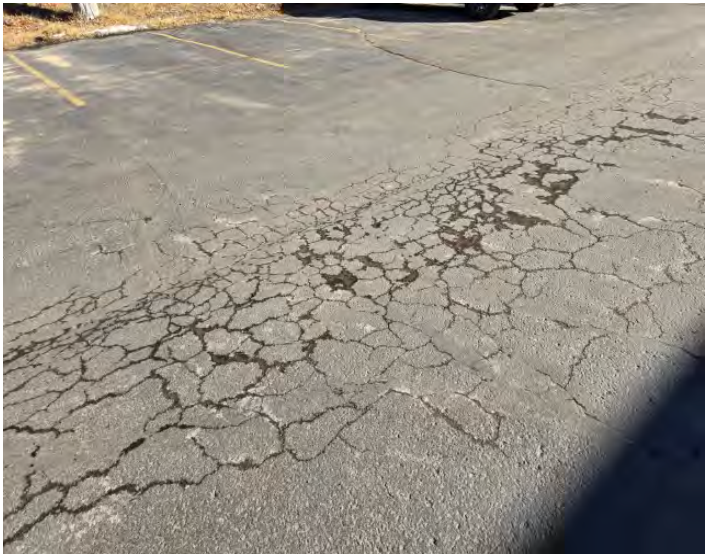
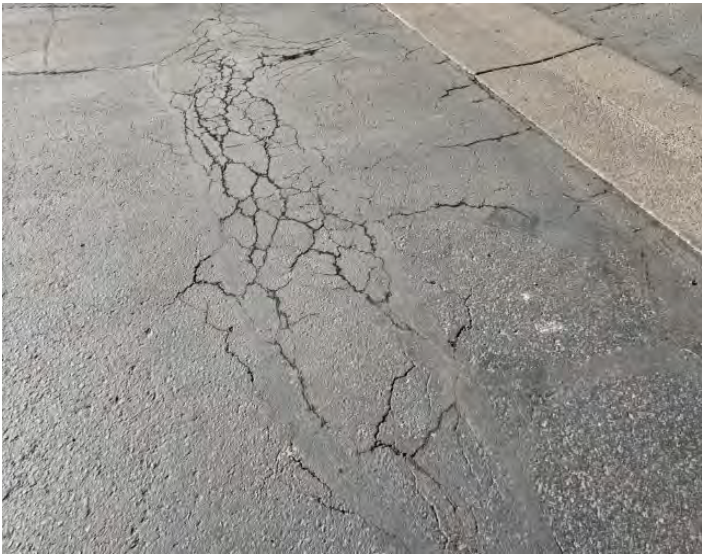
Asphalt - Major Overlay

- Numerous repairs are needed, but is not likely that the association will need a complete removal and replacement. We recommend a consultation with an asphalt contractor and obtain core samples to determine the thickness and stability of the asphalt and base before a final decision is made, but we believe repairs and a mill will be sufficient based on our observation and without the benefit of further inspections.
- At this time, we will fund an estimate for major repairs (possibly down to the base), mill and an overlay.
- The average life expectancy for asphalt surfaces ranges between 20-25 years for surfaces that are maintained on a regular schedule.
- Maintenance includes crack fill and repairing small potholes annually as an operating expense.
- In addition, asphalt should be seal coated every 3 - 4 years, depending on the level of traffic and snow removing techniques.

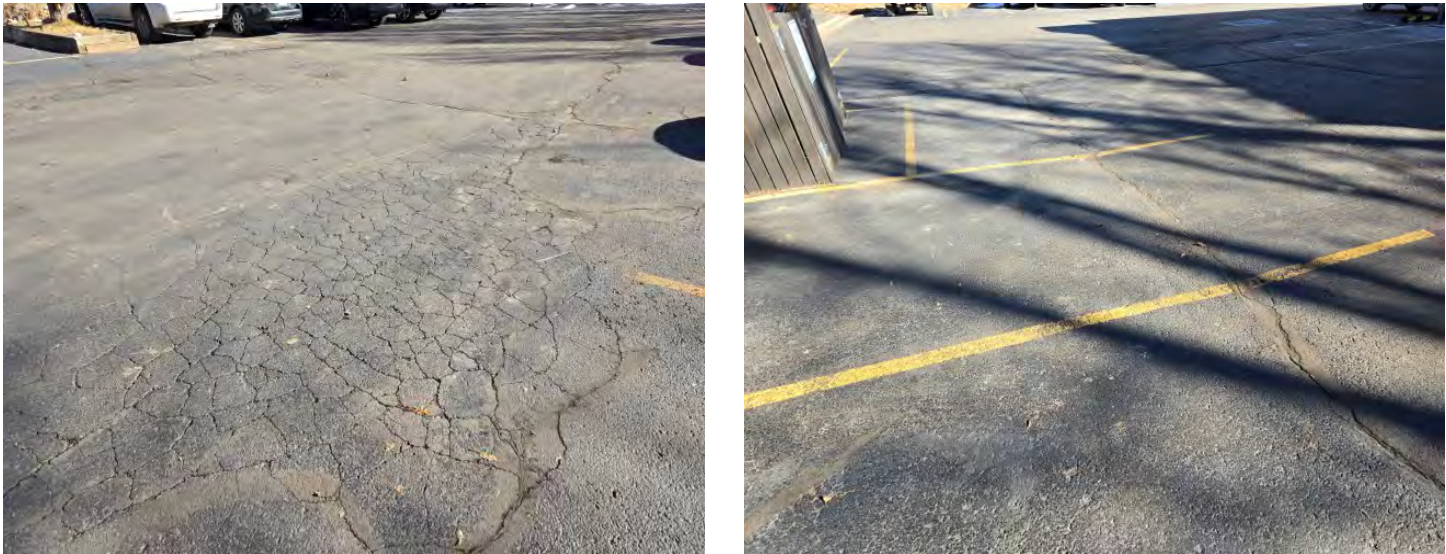
Asphalt - Surface Application

- It is important to maintain a proper seal cycle to protect the integrity of the asphalt and prevent extensive cracking, development of potholes, and loss of emulsion, which will lead to advanced deterioration.
- The current condition of this surface is beyond the benefit of a seal coat.
- As a result, we are recommending repairs, a rotomill and overlay of the existing surface.
- Industry professionals suggest seal coating within 12 months of a new overlay.
- Therefore, due to timing of an overlay (during summer months), we recommend seal coating the summer following a new overlay.

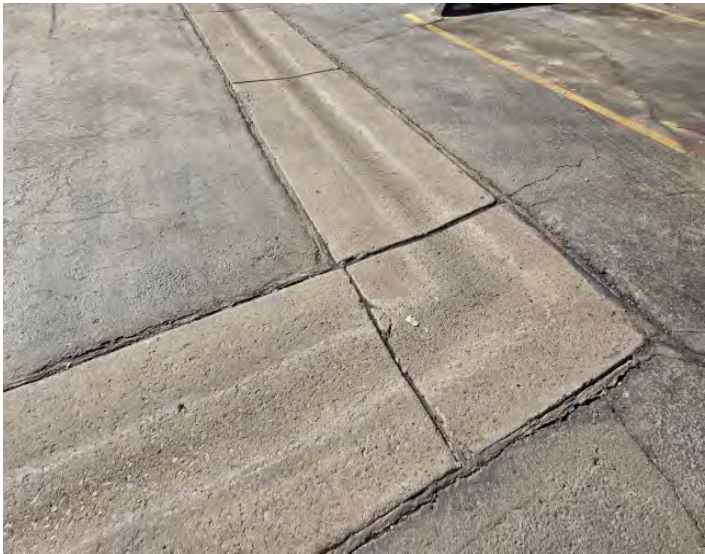
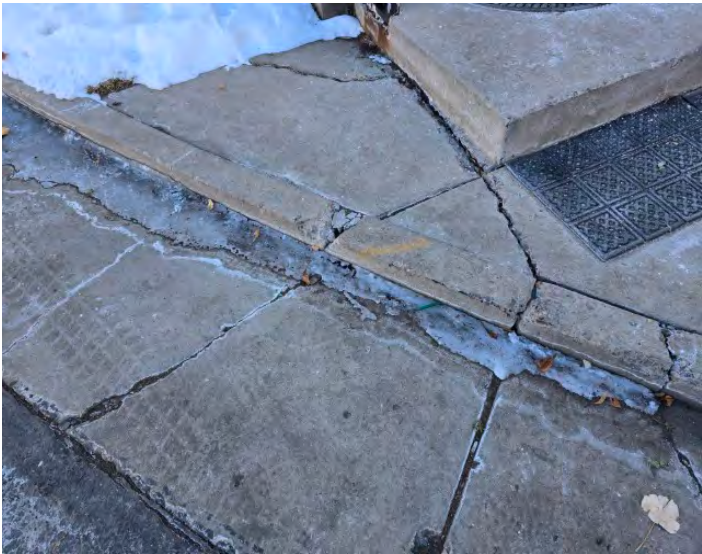
Drain Pans/Curb/Gutter - Repair/Replace

- It is possible the asphalt company will recommend a drain pan down the center of the drive to minimize deterioration to the asphalt over the years.
- We recommend coordinating these repairs along with asphalt work for best cost estimate since asphalt companies can also perform concrete repairs.
- Since it is unlikely that all concrete surfaces will need to be repaired at the same time, we have established an allowance for periodic repairs to a percentage of the total area every 4 years.

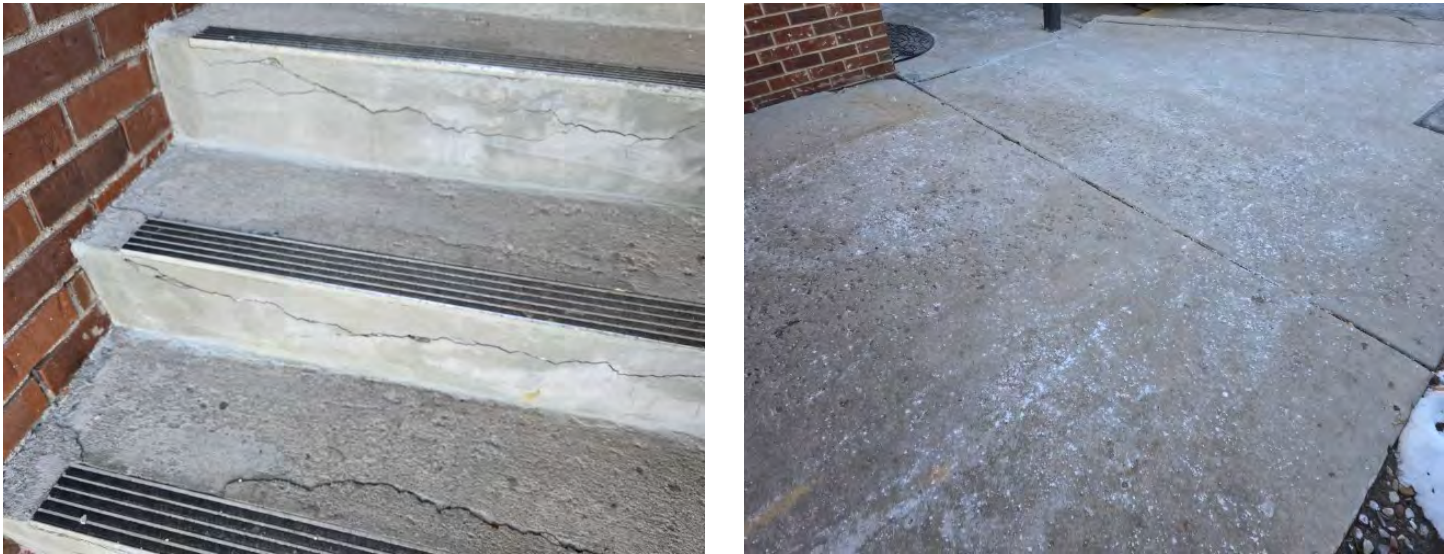
Concrete Flatwork - Partial Replace

- Concrete steps leading to the second floor of building #23286 are cracking and deteriorating and major repairs will be required in the near future.
- Similar to other concrete surfaces, it is unlikely all concrete surfaces will fail and need to be replaced at the same time.
- Therefore, we suggest establishing a Reserve fund for frequent repairs and replacement to a percentage of the area (10% or 685 GSF) every 4 years.
- Coordinate repairs with other concrete surfaces for best cost estimate.

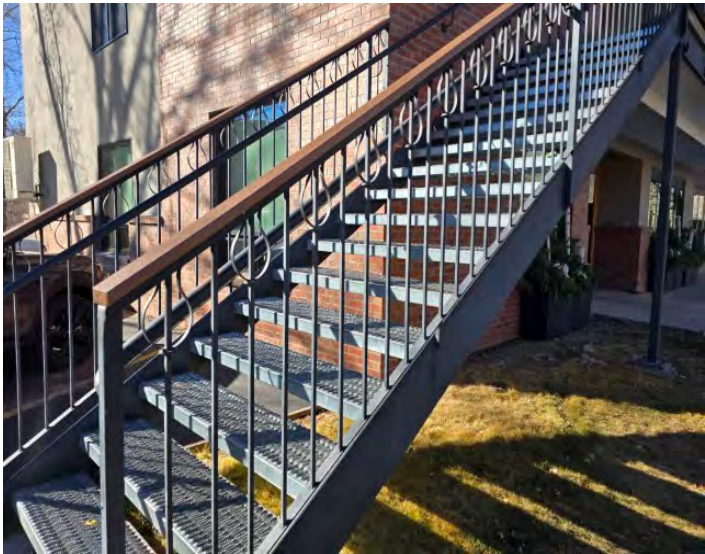
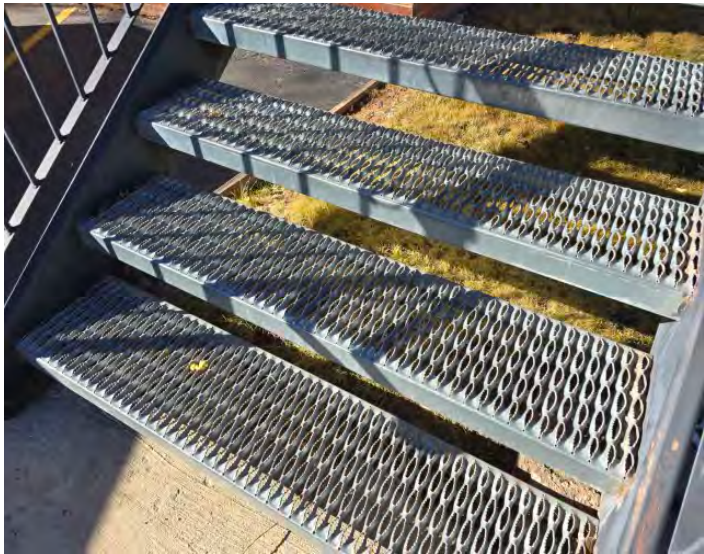
Steel Stairs - Inspect/Paint/Repair

- Some surface rust and faded paint was noted on the stringers of the stairways. No corrosion that will cause weaknesses in the materials were observed.
- In order to maintain the integrity of the stair systems, we recommend painting the structures every 4 - 7 years to protect the metal from exposure to elements that could cause deterioration.
- Other factors that will deteriorate the coating and metal surfaces is snow and ice melt that may be applied to the steps and landings.
- Based on the age of the building, we recommend Reserving an allowance for periodic inspections and addressing any required repairs at that time.
- Painting cost is included with the Exterior Surfaces - Repaint line item (See component #202)

*Best Cost:*               **\$5,000**  
Estimate for an inspection, minor repairs, painting

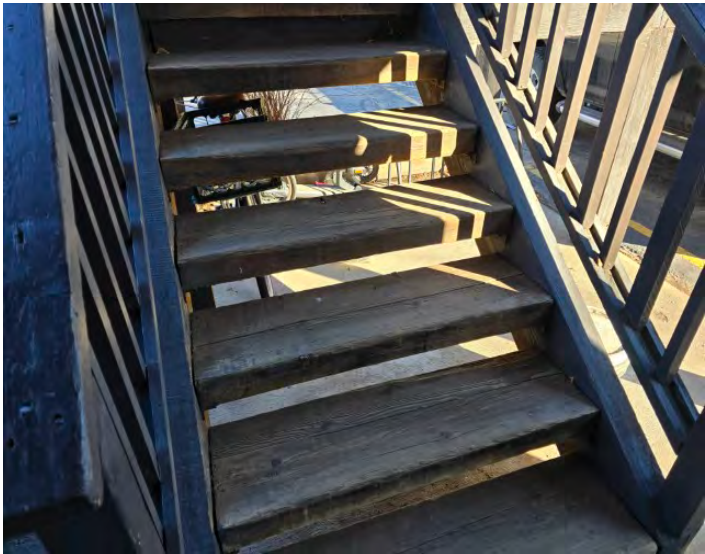
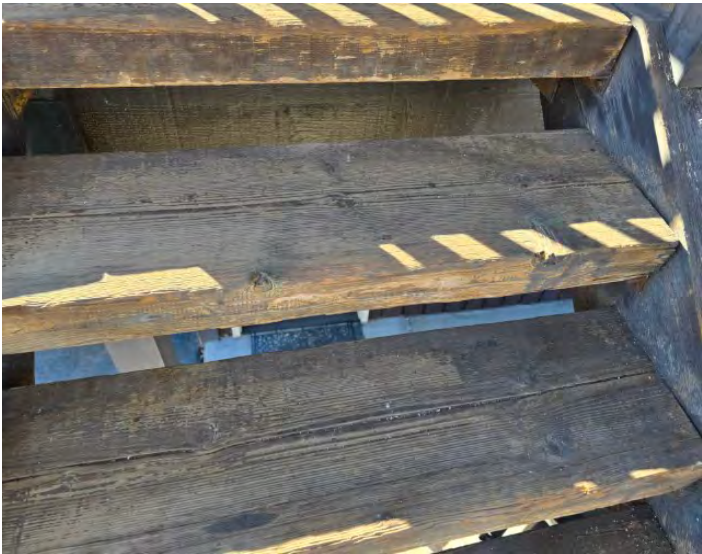
Stairway Systems - Major Repairs

- Stair system is stable and in good condition with normal signs of wear and tear noted. Treads are starting to show significant wear and could be slippery during wet or snowy conditions.
- Wood surfaces like this are susceptible to worn surfaces and rounded edges, which could cause slippery conditions over time.
- At this time, we recommend Reserving an allowance for major repairs (not complete replacement) every 10 years.

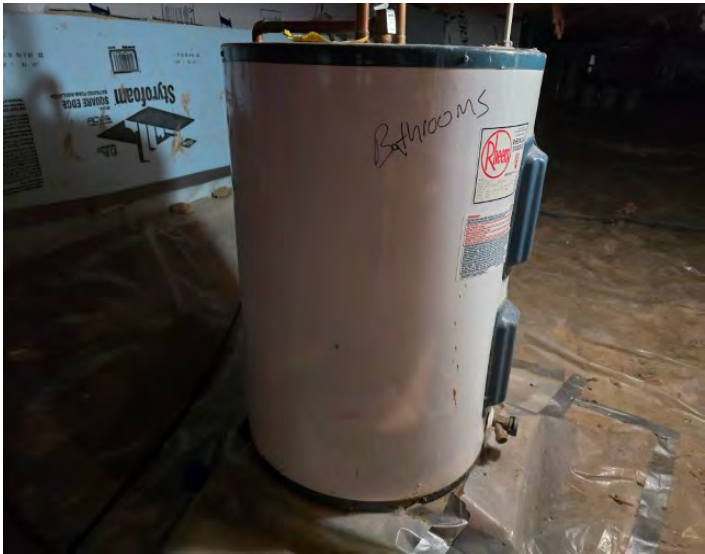
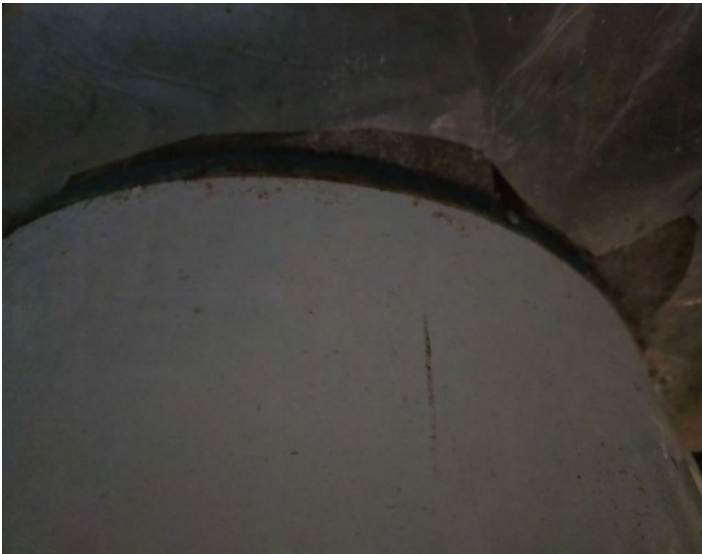
Water Heater - Replace

- Only able to access one of the heaters, but no reports of any replacement of any heaters, so assume all are of similar age and condition.
- These heaters are for the restrooms, and do not see heavy use.
- Expect a useful life of approximately 12 - 15 years from this component.
- Due to limited use, we have extended the life expectancy to 20 years.
- While current heaters are older than 20 years old and functional, we suggest the association plan on replacement at any time in the near future.
- Draining the tank once a year to clean it out will help achieve maximum life expectancy.

*Best Cost:*                **\$18,000**  
Estimate to replace and install

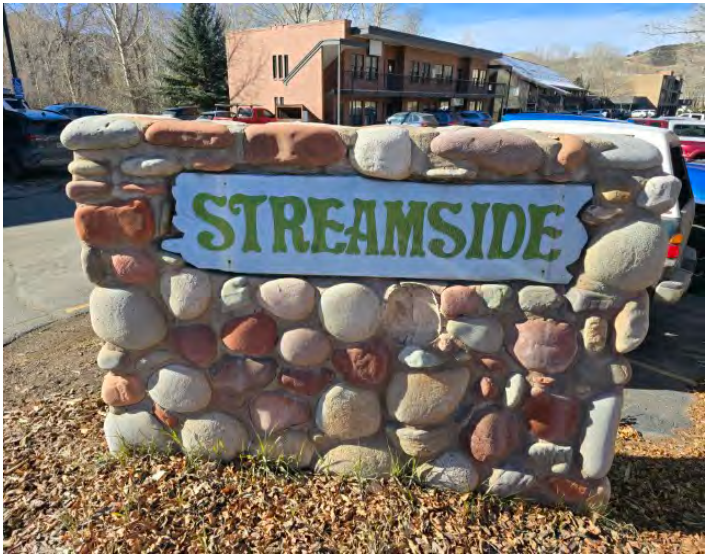
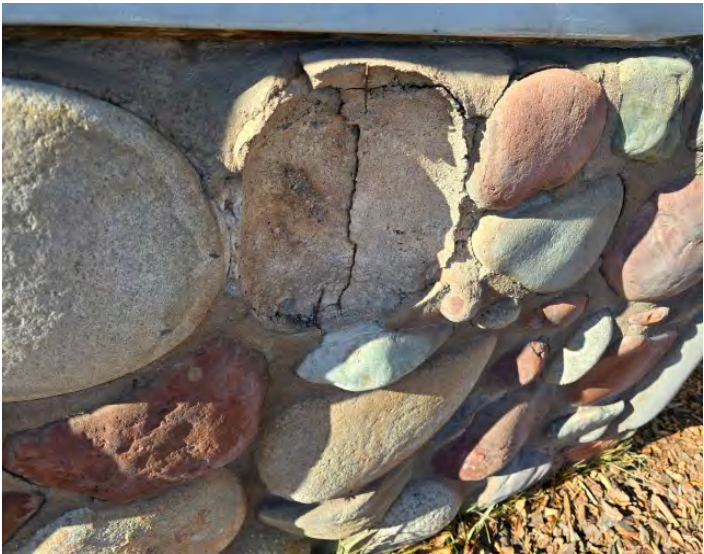
Monument - Rebuild

- Observations:
- We noted several loose rocks and a few cracks in the mortar.
  - It is unlikely that the monument will require replacement or rebuilding due to the materials failing.
  - However, over time, it is possible some of the facade will loosen and need repairs
  - Therefore, we have established an allowance to inspect and perform minor repairs/renovations to the monuments every 30 years
  - Remaining life is based on observed conditions
  - If the association decides to completely replace the monument and upgrade the appearance to a more modern look, it is likely the cost will be more than the rebuild allowance we are currently providing.
  - We can adjust the cost if the association informs us of a desire to change the monument

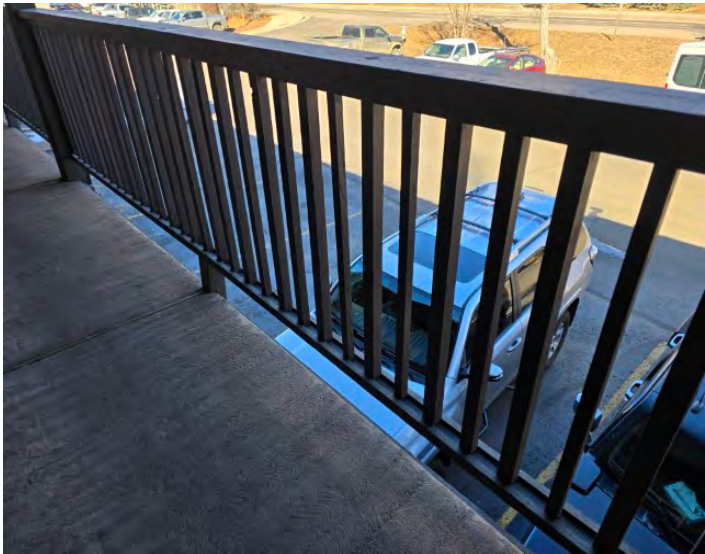
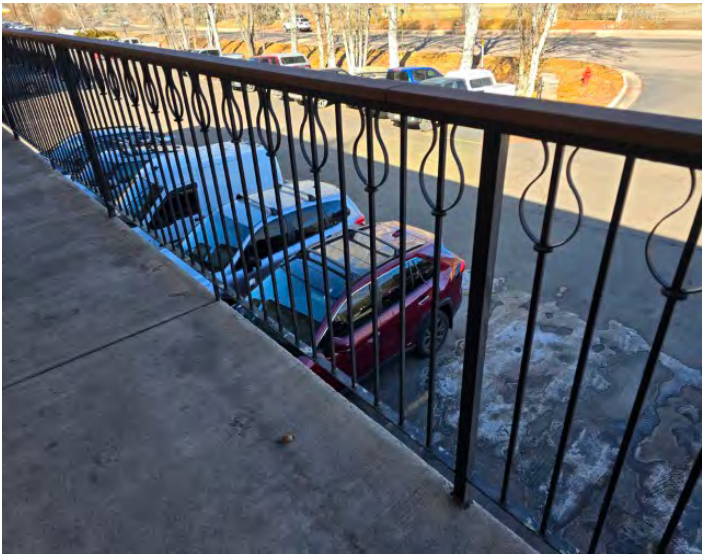
Comp #: 1002     Iron/Wood Railing - Replace

- All caps were replaced and the rails were completed painted in 2025.
- Rails are in very good condition and structurally secure.
- Due to the age of the building and the observed conditions, we recommend establishing an allowance for replacement of railings every 40 years.
- Because of the recent repairs and painting, we have extended the replacement cycle

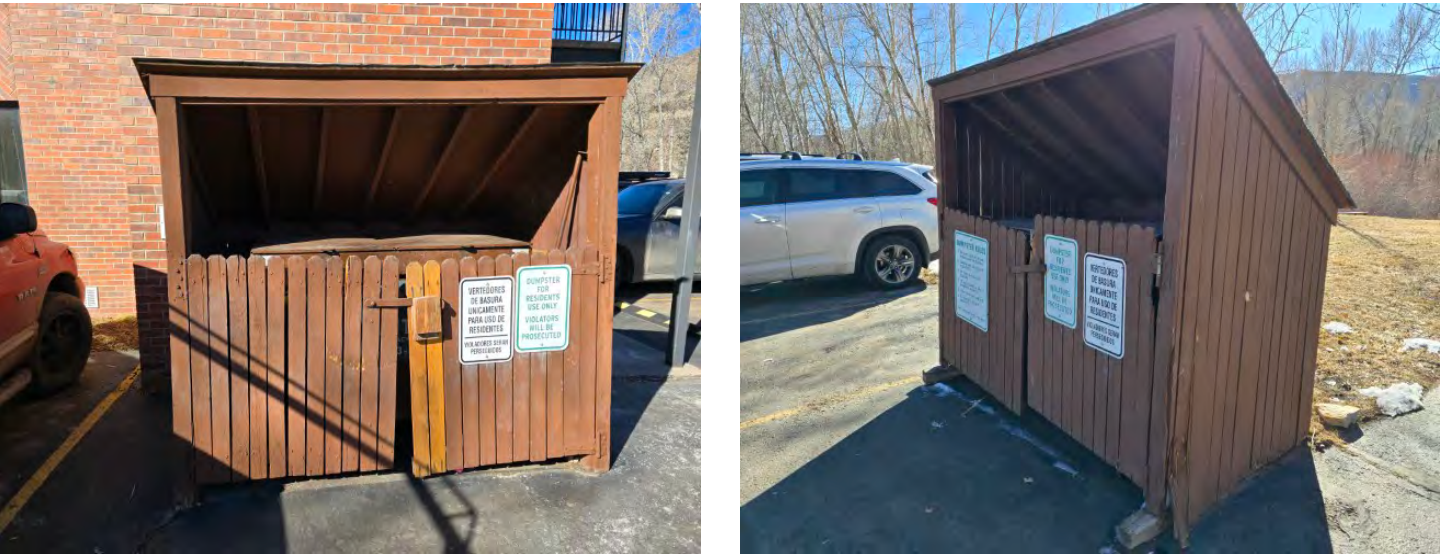
Trash Enclosures - Major Repairs

- Roofs were recently replaced, but we have included future replacement on a separate line item.
- Expect frequent repairs and replacement to the gates, and possibly the siding due to the exposure to elements and probability of abuse from rubbish companies.
- We recommend painting at the same time as the rest of the building exterior surfaces for best cost
- We have established Reserve funding for major repairs to occur every 10 years
- Coordinate with building repairs and painting since the same contractor can provide the repairs and painting at the same time.

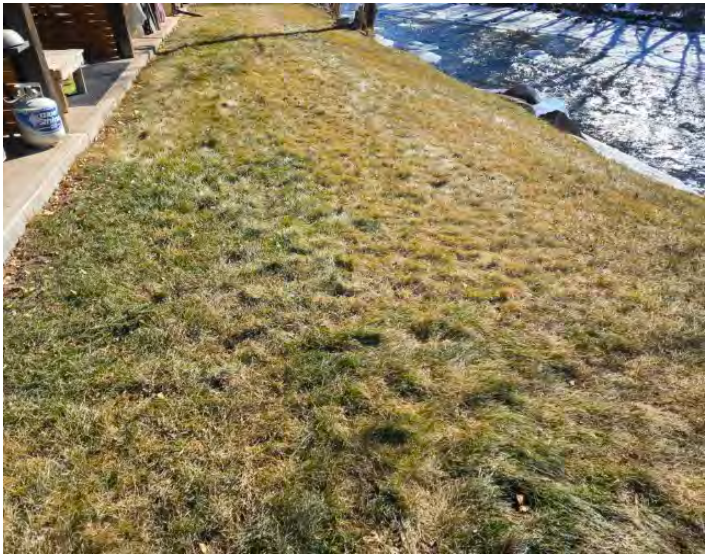
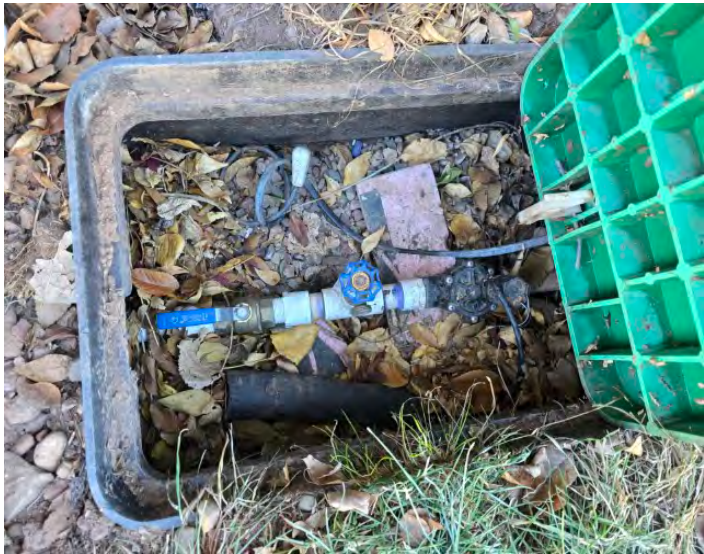
Irrigation System - Replace

- Due to tree roots pinching and affecting the flow of the water, it is possible the system will need to be replaced.
- We are recommending major replacement of the trees due to the root system crawling and spreading along the top of the ground.
- When the trees are replaced, the surrounding irrigation system should be replaced at the same time.
- With the major cost associated with replacing the trees and the irrigation system, we have established funds to replace a third of the system every 4 years to spread out the expense.

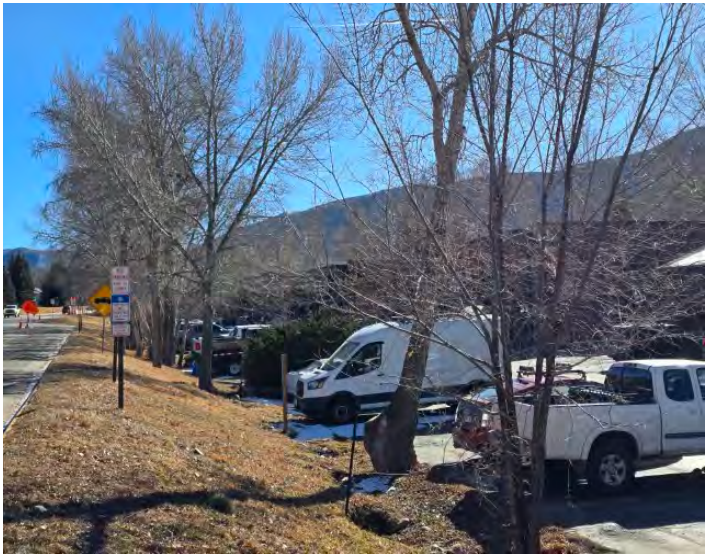
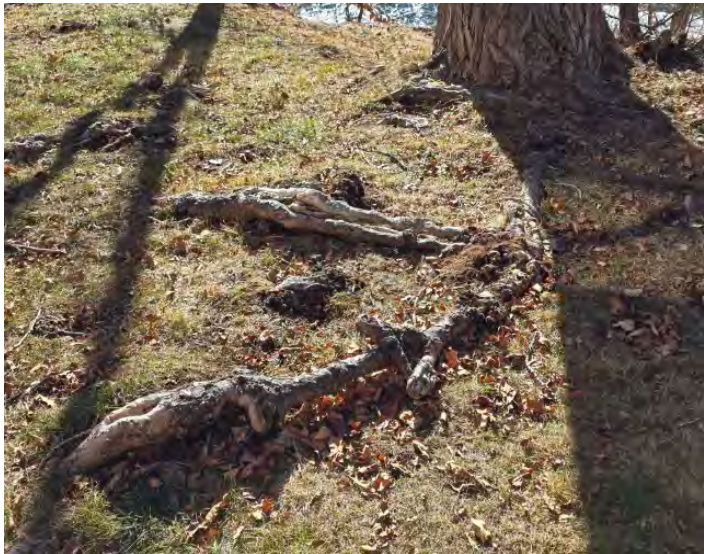
Tree - Replacement/Major Maintenance

- The trees along the river bank side of the community, the root system spreads out along the top of the ground, causing uneven surfaces and a dangerous situation.

- The association is suggesting replacement of these trees with a tree system that is more tap root style, rather than an aerial root system. The problem is the existing trees are very mature and not only beautiful trees, but will be very expensive to remove and replace with a new tree.

- Since it is difficult to predict when the replacement will be necessary, Reserve funding is typically not a factor.
- However, based on our recent experience, an allowance for periodic replacement has been included.

- This allowance is to provide funds for the association to address the trees as they desire and does not cover complete replacement of all trees along the river bank

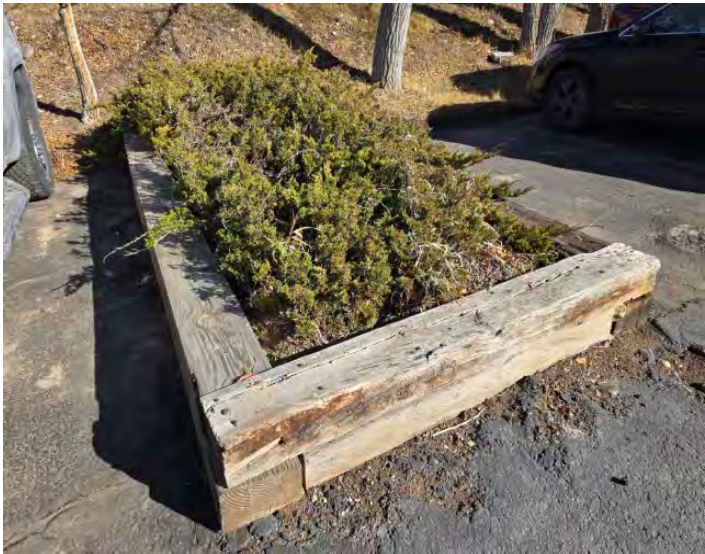
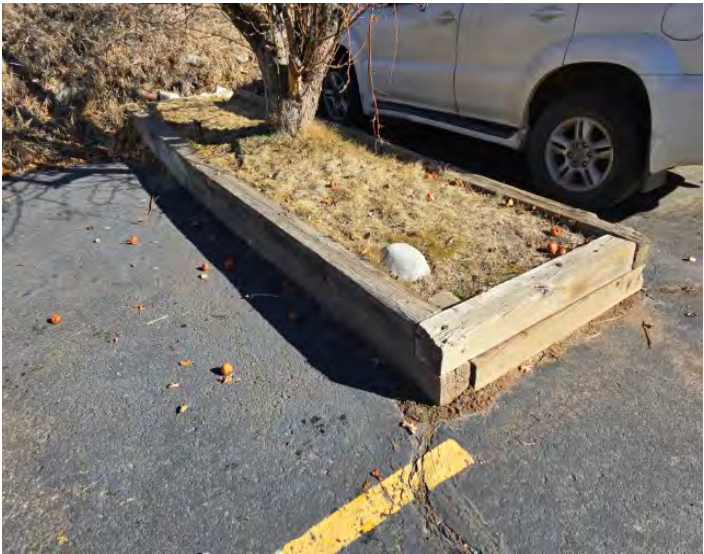
Planter Boxes - Rebuild

- It has been reported that they board is considering removing the planter boxes in the parking lot to add more parking spaces.
- When the planter next to the fire hydrant is removed, we recommend striping the area and installing bike racks in the area since the fire hydrant cannot be blocked by cars
- This is a one time expense since once these are removed, future funding would not be required
- The remaining life is coordinated with the asphalt work so the asphalt company can remove these areas and pave the areas for additional parking

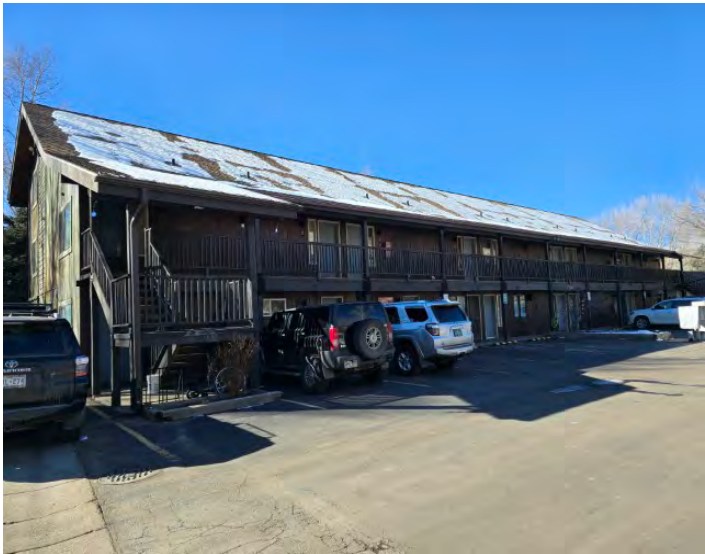
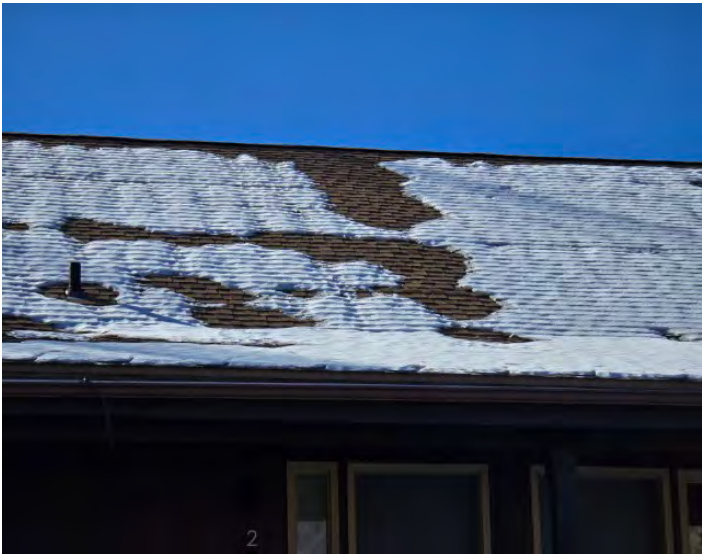
Roof Issues - Building A

- It was reported there is a condensation issue going on inside the units of the A building.
- It is possible the condensation is a result of the insulation between the ceilings and the roof sheathing.
- The exact reason and solution will not be revealed until the roof is removed and a detailed inspection is completed
- Since the solution to the problem can vary drastically, we recommend addressing the expense as a separate issue from the Reserve account
