Regarding: Reserve Study Final Version

Level 2, Premium Reserve Analysis

# Roaring River Lodges Condo Assoc. 23300 Two Rivers Road Basalt, CO. 81621

## FINAL VERSION

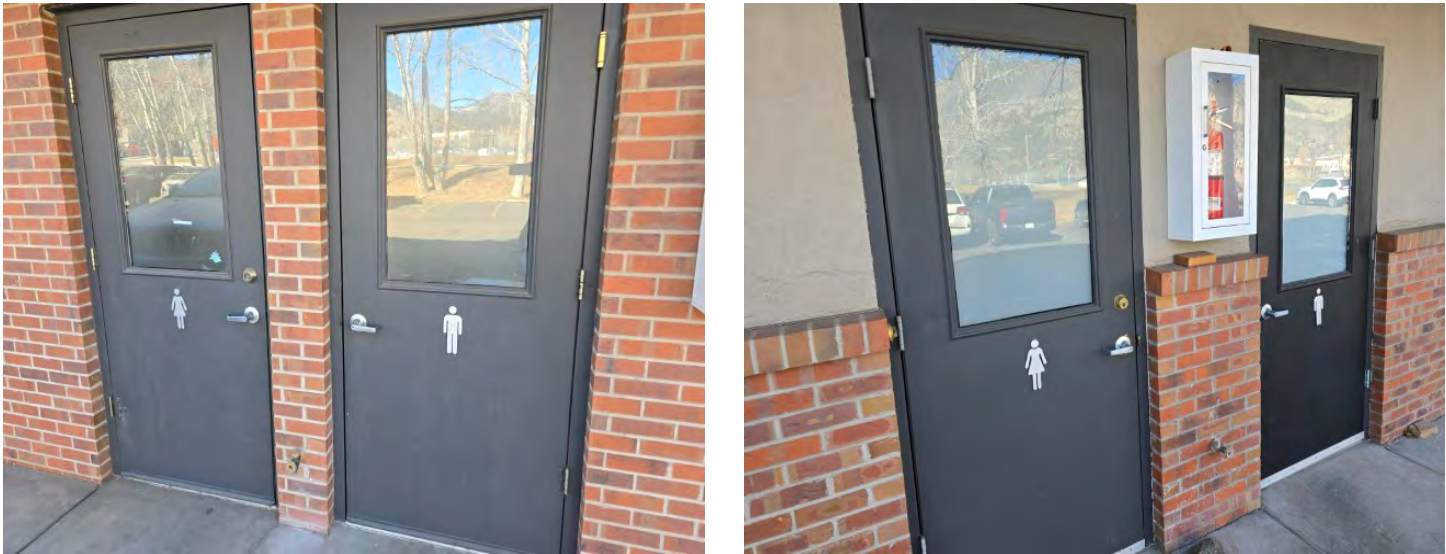
Comp #: 501

Common Doors - Replace (Restrooms)

- In our experience, we have seen the need to replace these doors every 30 - 35 years, depending on the amount of exposure to elements and the frequency of painting to protect the materials from advanced deterioration.
- Doors were fully operational with no problems noted.
- Remaining life is based on observed conditions and expected level of use these doors will receive over the years

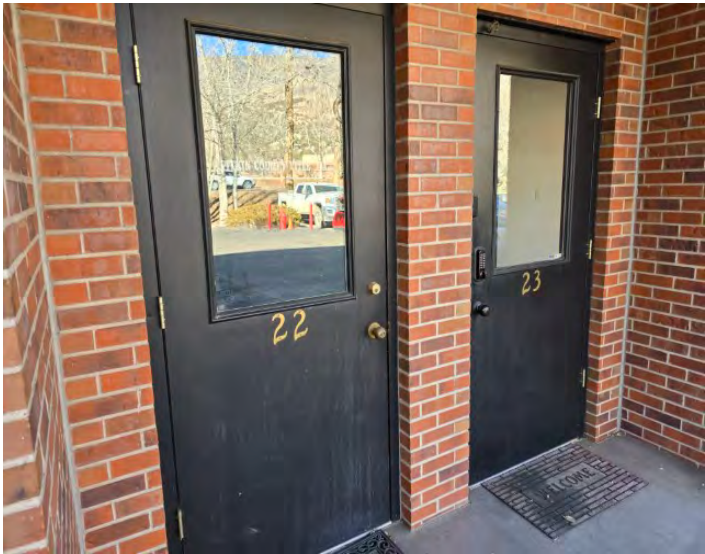
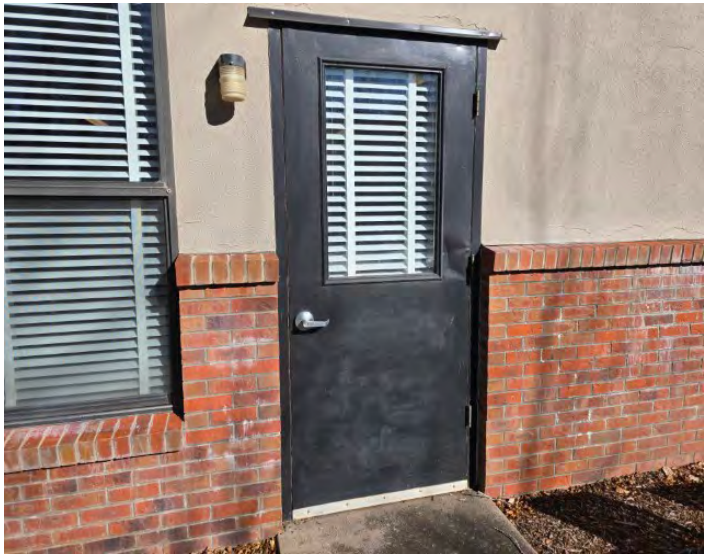
Comp #: 501      Unit Doors - Replace

- Observations:
- It has been previously reported that these are the responsibility of the unit owner
  - Therefore, separate Reserve funding is not required for this component.

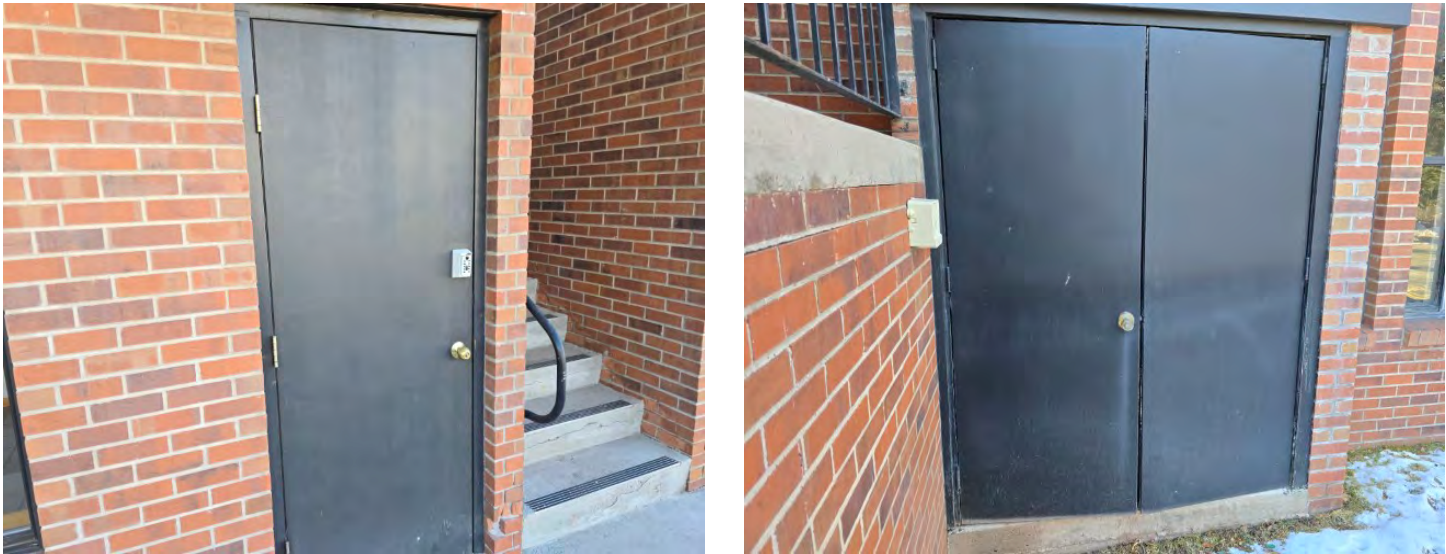
Comp #: 503

Utility Doors - Replace

- These doors are steel doors and as long as they are painted frequently, the replacement cycle can be extended
- In our experience, we have seen the need to replace these doors every 20 - 30 years, depending on the amount of exposure to elements and the frequency of painting to protect the materials from advanced deterioration.

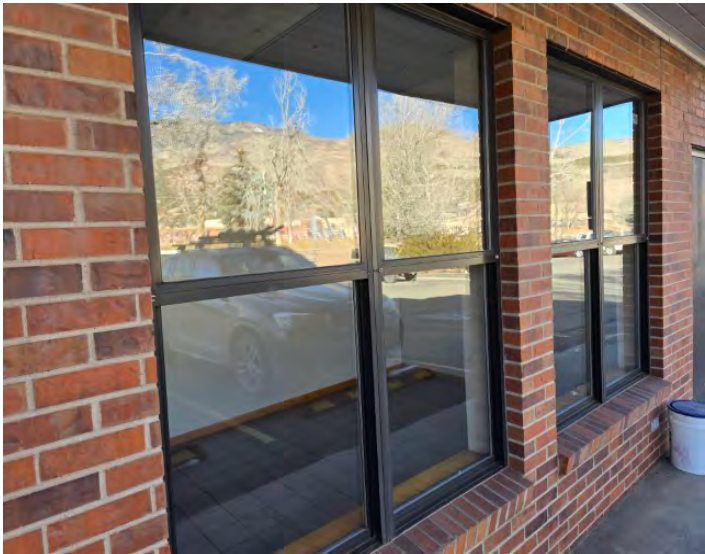
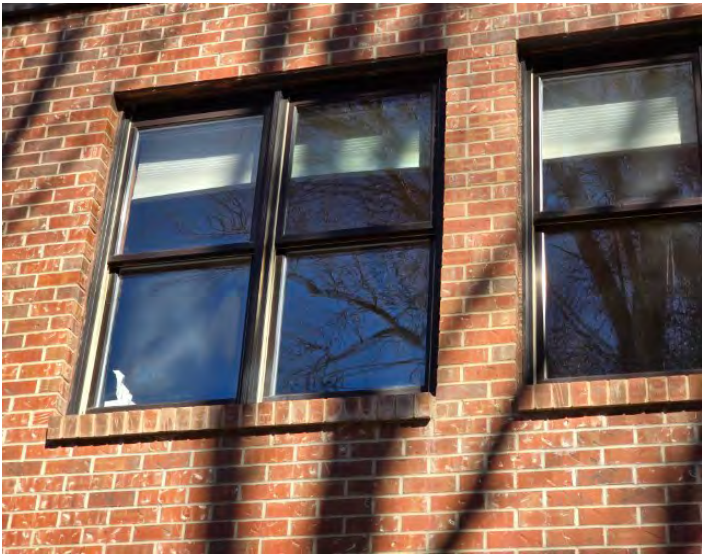
Comp #: 506

Windows - Replace

- Typically, windows are the responsibility of each individual owner.
- Therefore, separate Reserve funding is not required for this component at this time.

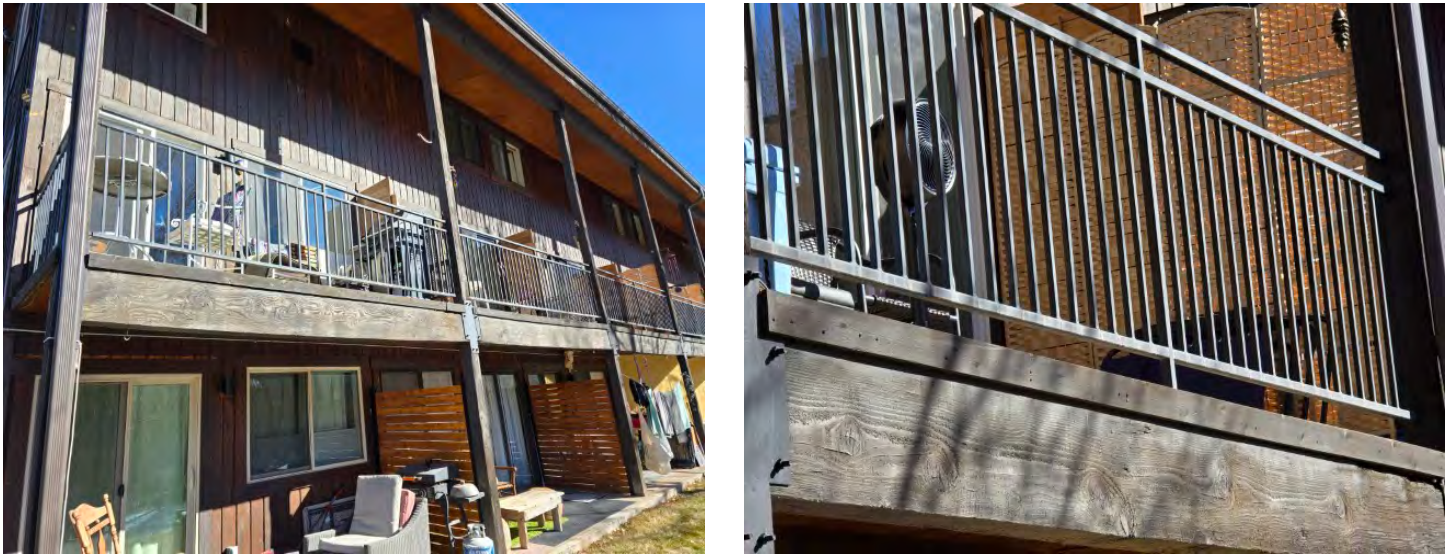
Comp #: 607

Unit Decks - Replace

- Typically, these are considered to be exclusive use common areas, and in most situations, the individual owner is responsible when major repairs or replacement is necessary.
- Therefore, at this time, separate Reserve funding for replacement is not recommended, unless determined and reported to be an HOA responsibility

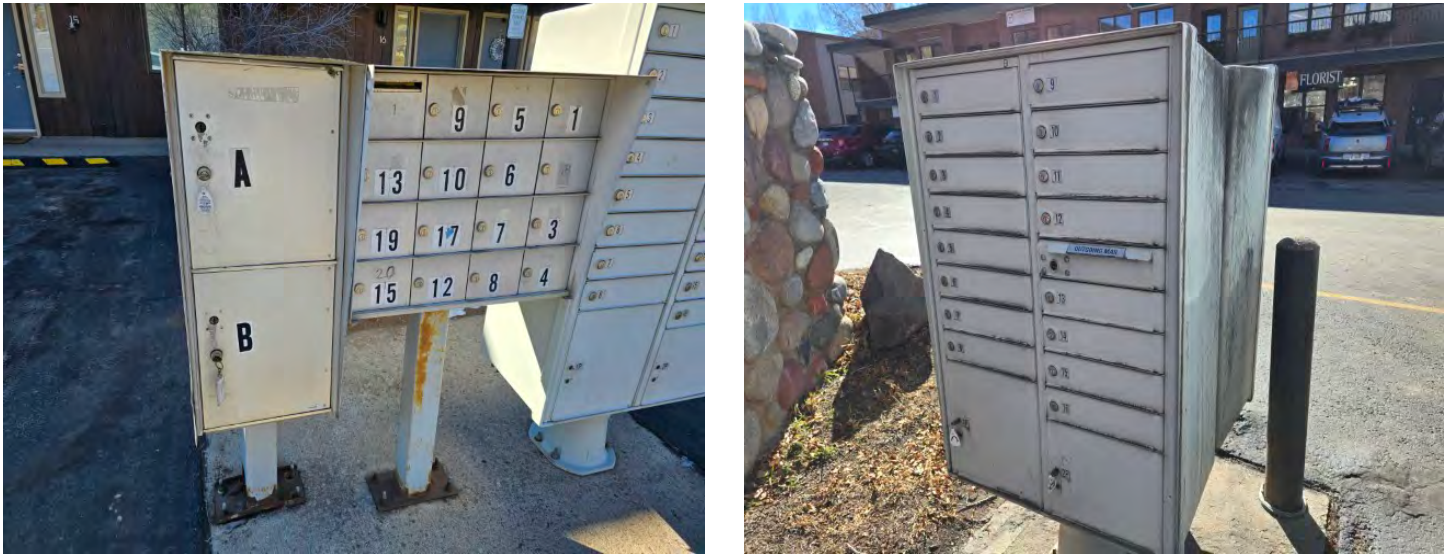
Comp #: 803

Mailboxes - Replace

- According to several manufacturers, the typical life expectancy for this type of mailbox is 20 - 25 years in this environment.
- Remaining life is based on average age of all units.
- Per new Postal regulations effective 2012, "all customers are responsible for repairs and replacement of keys, locks, or the boxes/cluster units themselves".

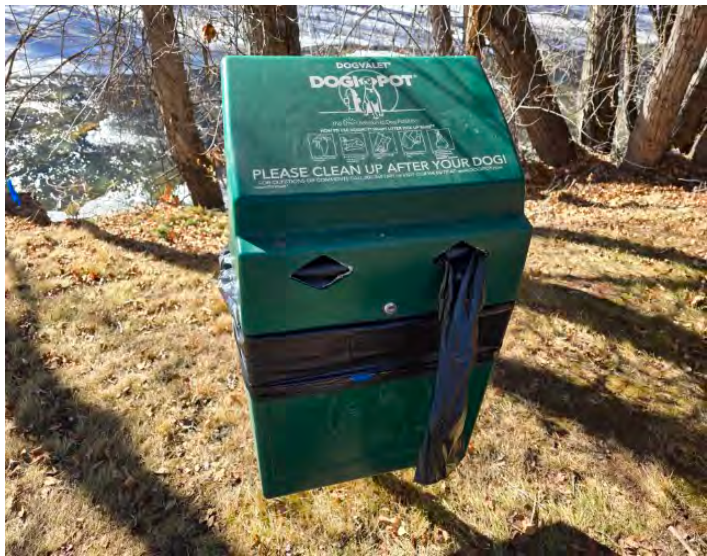
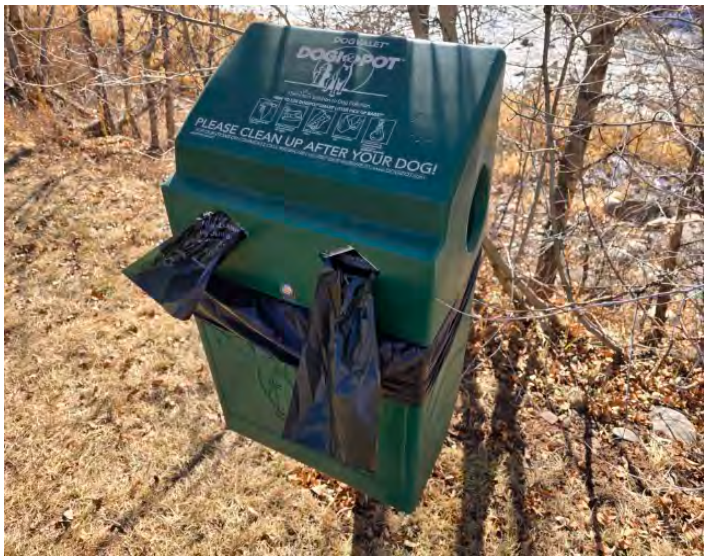
Comp #: 1311      Pet Waste Pick Up Stations - Replace

- All stations have been replaced since prior reserve study with larger Dogi-Pot units
- Due to the low quantity, unlikely event that all will require replacement at the same time and the relatively low cost of individual replacement, we do not recommend reserving for replacement at this time.
- Maintain and replace on an as needed basis using operating funds.

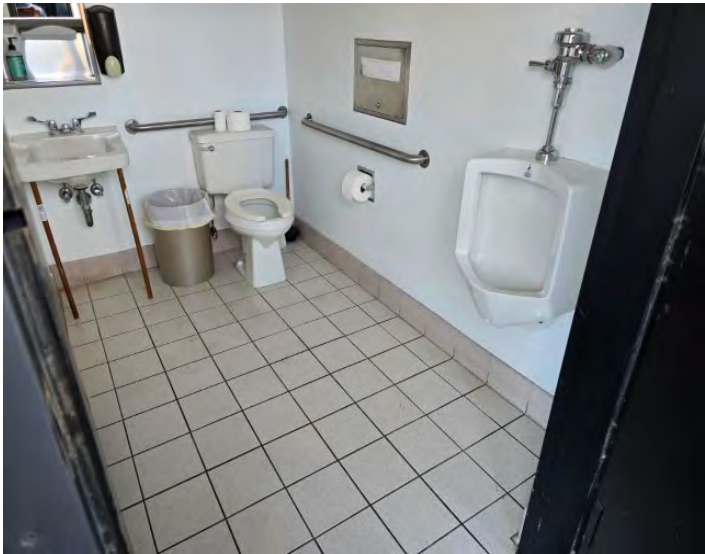
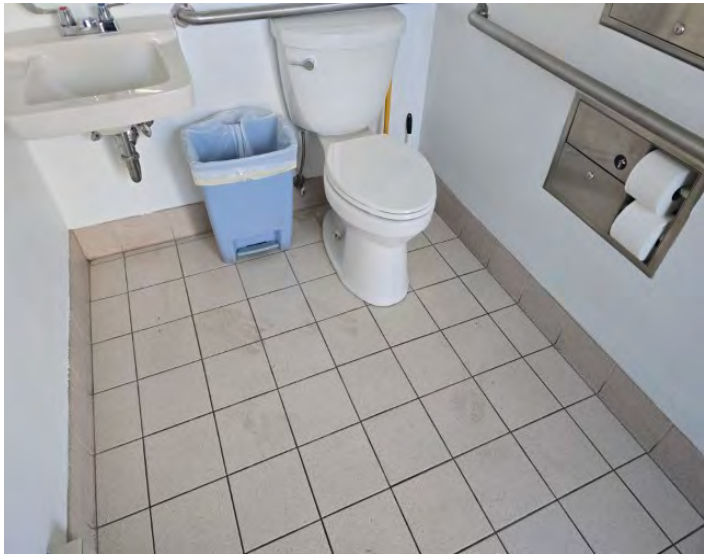
Comp #: 1413

Restroom - Remodel

- Depending on the amount of use this restroom receives, we expect the association to perform a basic upgrade every 15-20 years to maintain an appropriate appearance.
- The final decision is up to the community members in deciding when to spend the money to perform this project since it is considered cosmetic

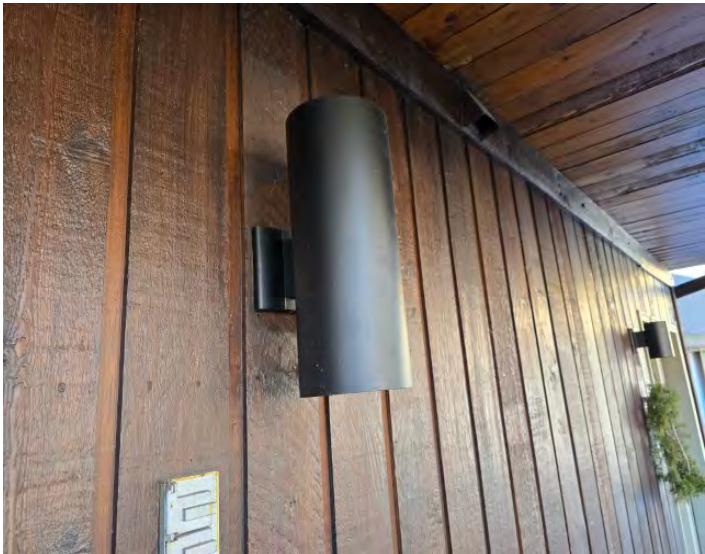
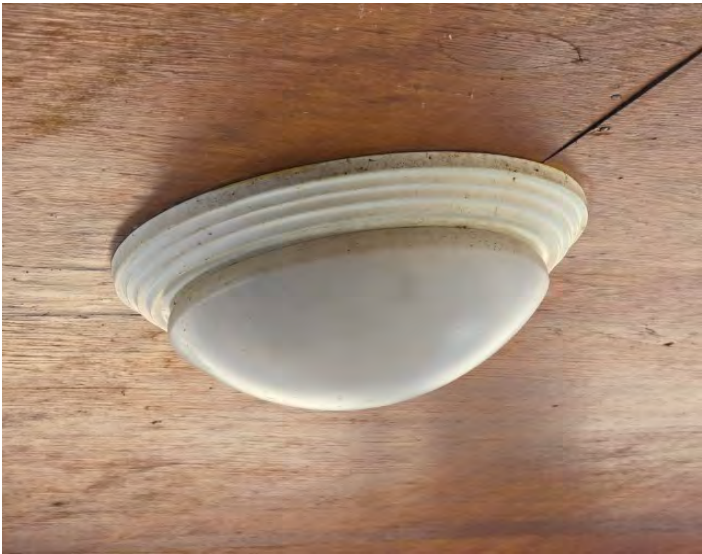
Comp #: 1602

Exterior Wall Mount - Replace

- It was reported that the lights were replaced at bldg. 23284
- The cost of the can lights and "jar" lights at the rear of the building is too small for separate Reserve designation.
- Therefore, separate Reserve funding is not required for this component at this time.
- However, since the lights on the residential building were all replaced at the same time and they are all consistent in appearance, we will Reserve to replace the residential lights only.
- The rest of the lights should be replaced as needed with general operating funds.

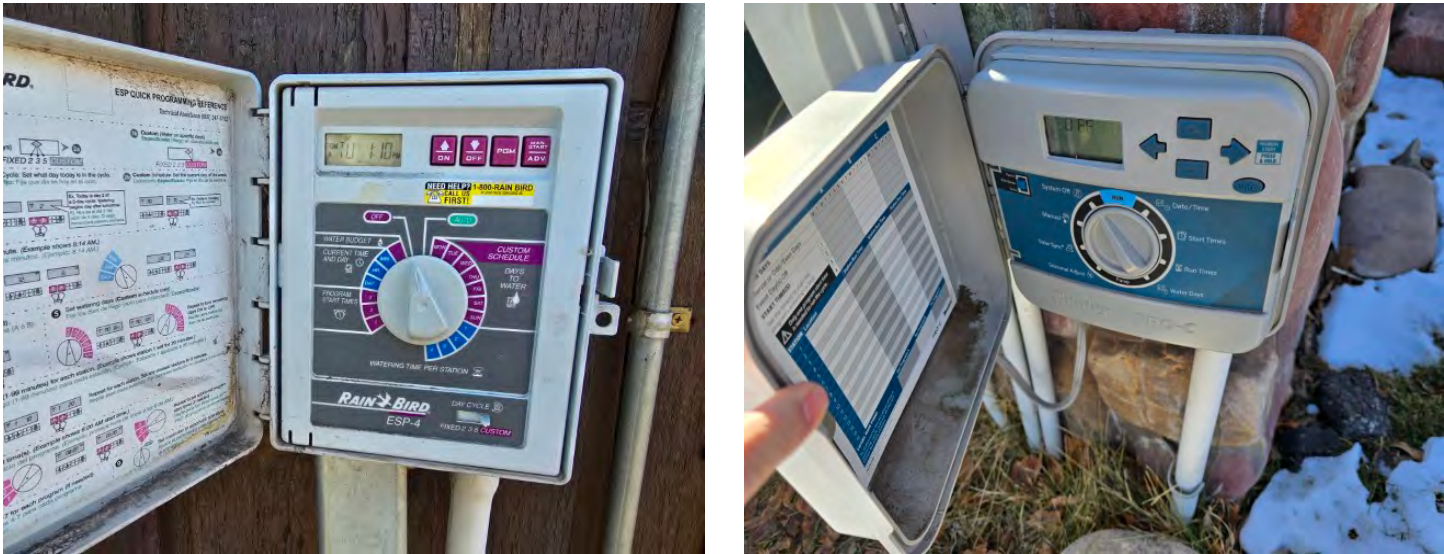
Comp #: 1703

Irrigation Controllers - Replace

- Observations:
- Due to the minimal replacement cost associated with this controller, Reserve funding is not appropriate.
  - Replace as necessary as an operating expense, or include with irrigation system repairs (see component #1701)
